CASE STUDY

Hydro-Dyne Helps Romeoville Increase Efficiency and Reduce Maintenance Costs with Great White Center Flow Screen

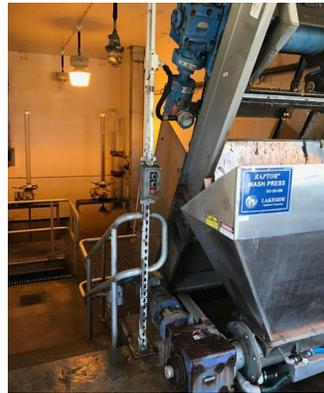
Figure 1

The city of Romeoville, Illinois, was struggling with outdated wastewater treatment equipment that was inefficient at removing solids, as well as difficult and time consuming to maintain. The existing 6mm catenary style screen system, installed in 2006, (Figure 1) required daily maintenance and cleaning, which took time and attention away from other responsibilities within the plant. In addition, too many solids were getting through the influent screens, putting a strain on other equipment and forcing operators to use pool nets to remove those solids from the primary clarifier every day.

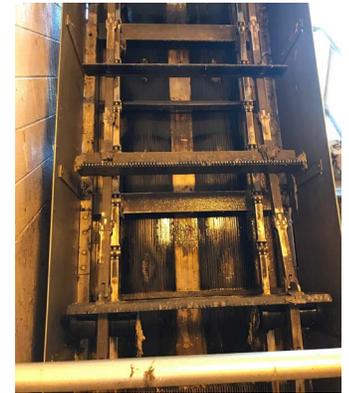
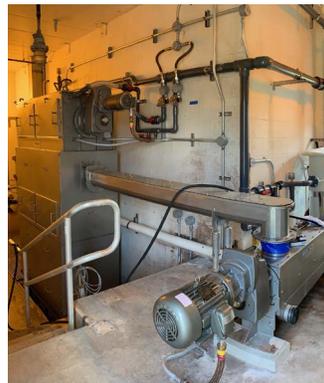
Figure 2

In 2019, Romeoville replaced the existing screening equipment with Hydro-Dyne's Great White Center Flow Screen with 6mm UHMWPE Perforated Plates and a Whitetip Shark Washing Compactor (Figure 2). The Great White Center Flow design promised a higher screening capture ratio with much lower operating and maintenance requirements. The Hydro-Dyne perforated panels were drilled and custom engineered to allow for higher throughput capable of passing Romeoville's peak wet weather flows and meeting their required head-loss and bypass water levels with no civil modifications.

Secondary access panels were also added at the lower deck for operators to evaluate the grid to ensure the wash water headers were offloading properly.

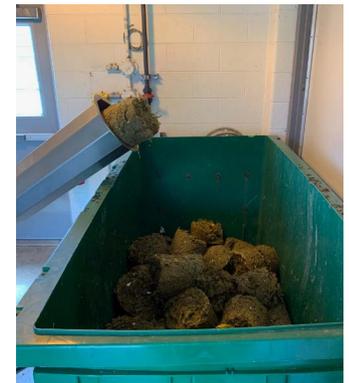
Figure 3

- Solids that are removed are dryer and much more compact (Figure 3).
- The new screen has greatly reduced the costs associated with rags collecting in downstream equipment; operators are no longer required to do the messy job of removing solids and rags by hand from their clarifiers, pumps, and slide gates, allowing them to focus on optimizing their plant.
